**FIRST YEAR OF OPERATION OF HPGR AT TROPICANA GOLD MINE –
CASE STUDY**

*Andrew Gardula¹, Dilip Das¹, Mike DiTrento², and Sandra Joubert²

ABSTRACT

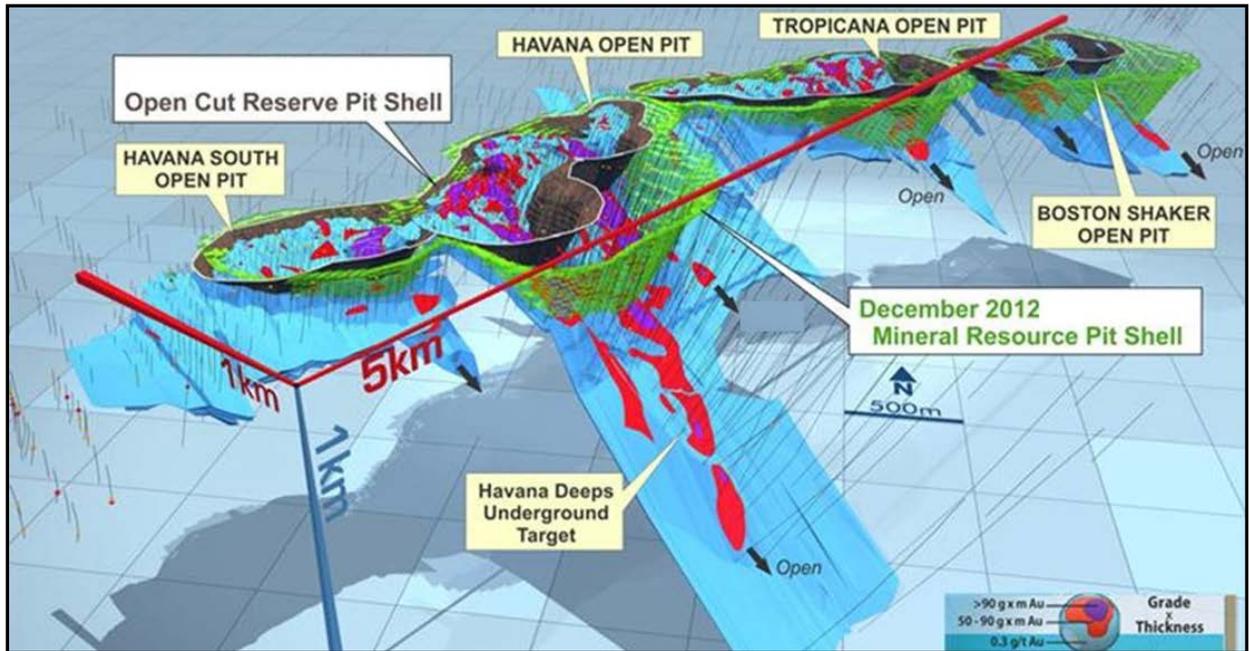
The ore body mined by Tropicana Gold Mine is composed of Tropicana, Havana, Havana South and Boston Shaker deposits. Currently the mining operations are concentrated on the Havana and Tropicana open pits.

Figure 2 - 3D image of Tropicana Gold Mine deposit (courtesy of Anglo Gold Ashanti – Geology Department)

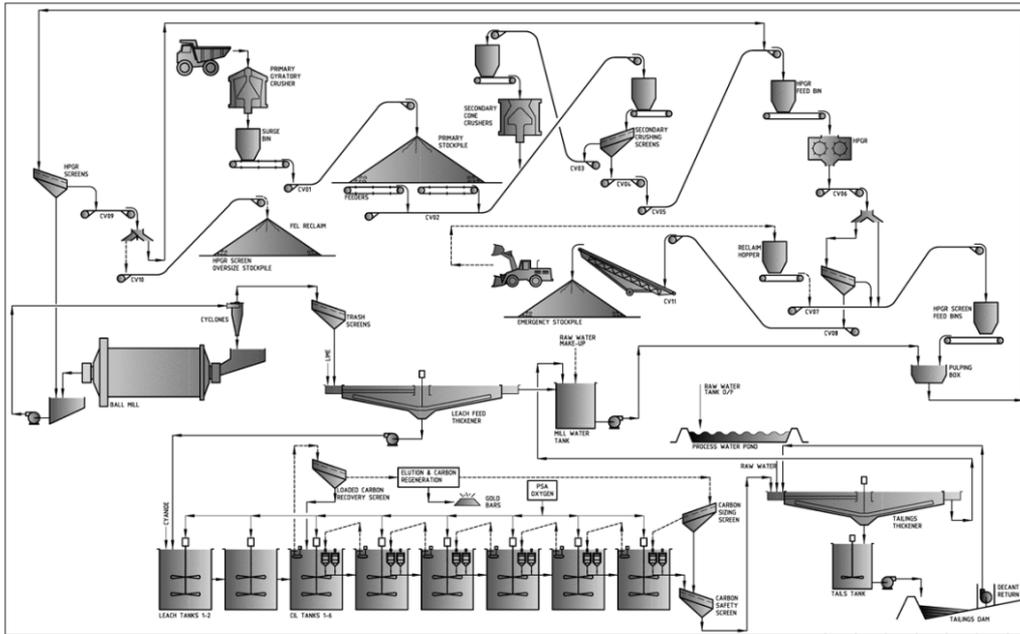
- Primary crushing – open circuit and stock pile
- Secondary crushing – circuit closed with 42 mm screen
 - Screen underflow reports to HPGR
 - Screen oversize recycled to cone crushers for re-crush
- HPGR – circuit closed with 4 mm screens
 - Screen underflow reports to Ball Mill
 - Screen oversize recycled to HPGR
- Ball Mill product reports to CIL process

Figure 3 - Process Flow overview (courtesy of Anglo Gold Ashanti)

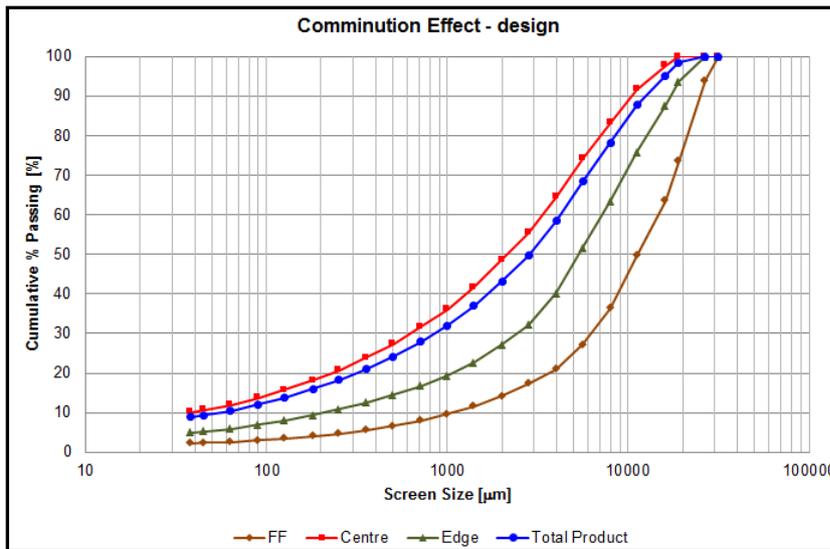
Reduction Ratio F_{80}/P_{80}

2.5

Reduction Ratio F_{50}/P_{50}

4.0

Figure 5 - Final test work result – comminution effect

- Process specific throughput constant (m-dot) 270 ts/hm³
- Specific pressing force 3,200 kN/m²
- Specific power consumption 1.7 kWh/t
- PSD results:
- P₈₀ 8.59 mm
- P₅₀ 2.85 mm
- % passing 4mm 58.4%
- % passing 125 □ 3.7%

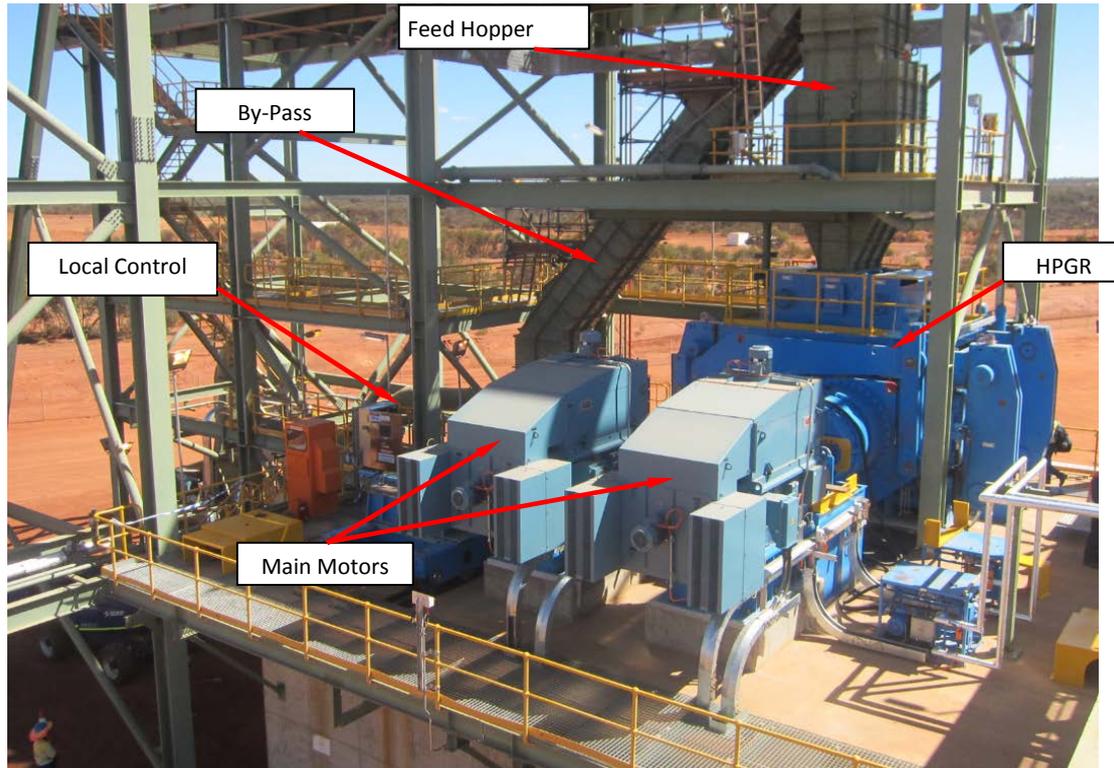
Figure 6 - Main view of HPGR installation at Tropicana (courtesy of Anglo Gold Ashanti)

The HPGR is installed on a concrete platform with the following floor plan:

- On the top deck – HPGR, drive train, gear box cooling and local control panel
- On ground level (below the platform) – hydraulic power pack and lubrication system.

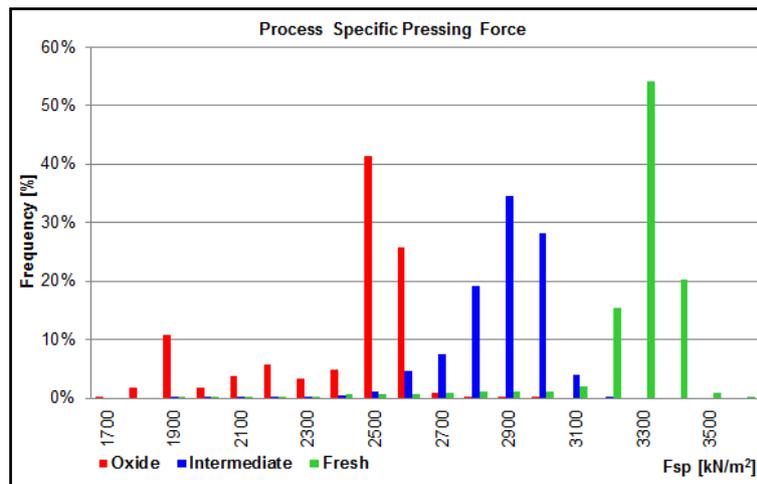
Figure 7 - Process Specific Pressing Force

The histogram presents specific pressing force adjustments that were required to maintain adequate comminution effect while processing oxide, intermediate and fresh ore blends.

The histogram of oxide ore (red) is much wider compared with intermediate and fresh ores. This is the result of fluctuation of ore properties during this period. Increase of ore competency (intermediate and fresh ore) resulted in better stability of selected specific pressing force.

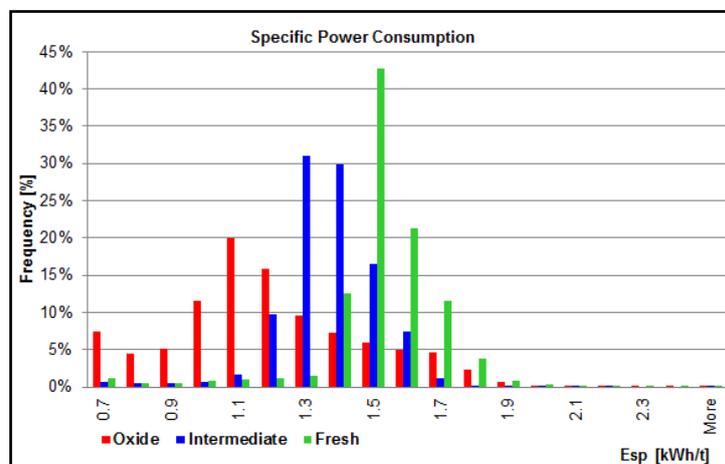
As predicted by the test work during the initial operation on oxide ore, specific energy consumption was considerably lower however it increased once ore competency increased.

Figure 8 - Changes in specific energy consumption for the oxide, intermediate and fresh ore

Specific power consumption is a function of specific pressing force and ore competency. On average, the following energy input was required:

- Oxide mean 1.14kWh/t Std Dev 0.301
- Intermediate mean 1.32kWh/t Std Dev 0.147
- Fresh mean 1.47kWh/t Std Dev 0.183.

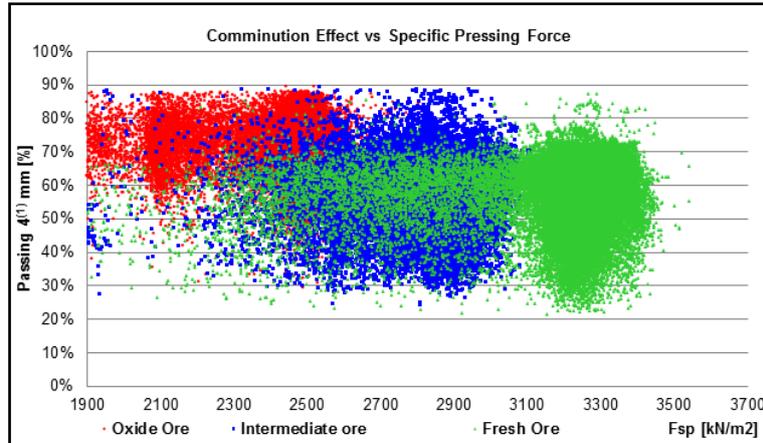
Fig. 9 - Comminution Effect

Please note the data for fresh ore appears to show lower comminution effect. During 2014 (July) the screen aperture was reduced from 4 mm to 3 mm in order to increase processing plant throughput. This change resulted in slightly lower comminution net effect.

The scatter graph presented on Fig 9 demonstrates changes in comminution effect for the three different types of ore. Following mean comminution effect was achieved:

- Oxide mean 72.0% Std Dev 0.074
- Intermediate mean 60.1% Std Dev 0.077
- Fresh (-3mm) mean 57.1% Std Dev 0.088.

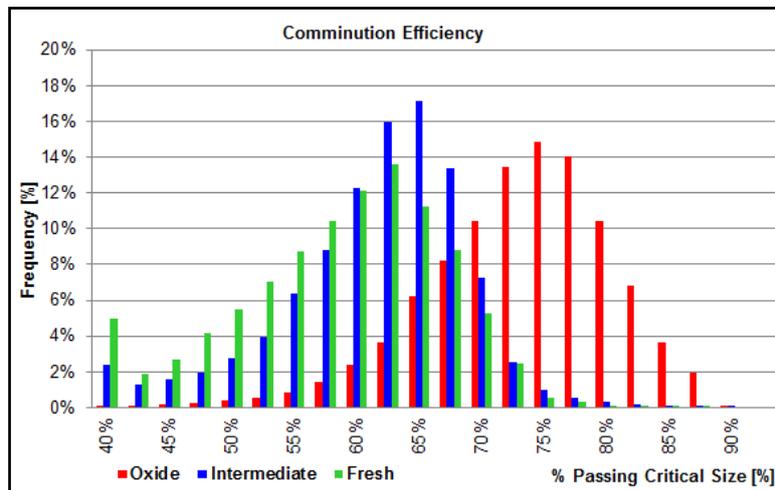
The histogram below presents comminution effect for the three analyzed periods of operation.

Figure 10 - Comminution Efficiency histogram

As predicted, the best comminution efficiency was achieved when processing weak oxide ore. Specific pressing force adjustments for operation on intermediate ore and later fresh ore resulted in maintaining comminution efficiency better than the design case (42%).

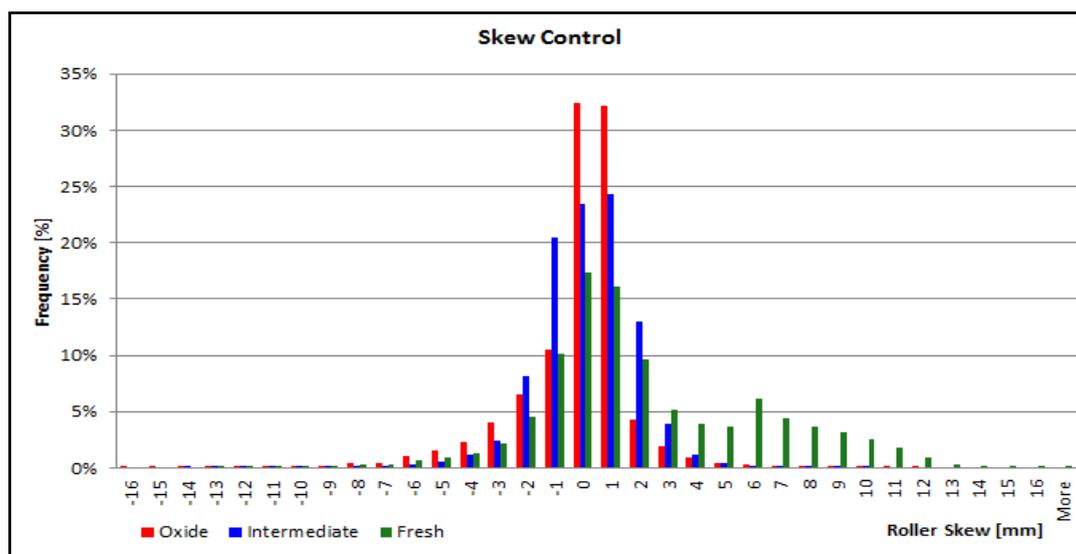
Figure 11 - Skew control during selected operation period

Roller skew presented on Figure 11 is calculated as a difference of roller gap between HPGR drive and non-drive ends.

The control loop performs very well with the occurrence of excessive skew very rare. The graph presented on Figure 11 shows wider distribution of roller skew for the operation on fresh ore. This period of operation corresponds to wear lining after more than 8,000 of on-load hours. At this stage the lining developed a “bath-tub” profile and as such skew control was more challenging.

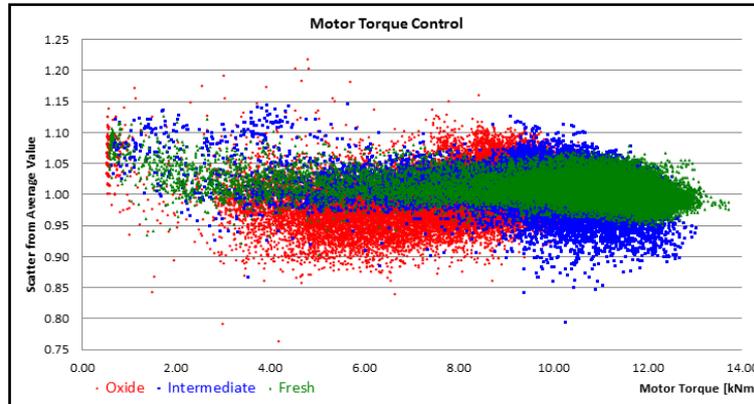
Figure 12 - Motor torque control

The scatter graph presented above shows deviation from average motor torque for each data point, in the event of floating and fixed roller motor torques are the same, the proportion of torques is “1” (flawless control). A difference between the torques is represented by values that are smaller or greater than “1”.

Motor torque control was a challenging exercise during the operation on oxide ore. Lack of process stability and ore homogeneity within the first months of operation were contributing factors to a larger scatter of motor torque.

Once the ore changed to intermediate and later fresh ore the target of motor torque being within +/- 10% of the average was achieved.

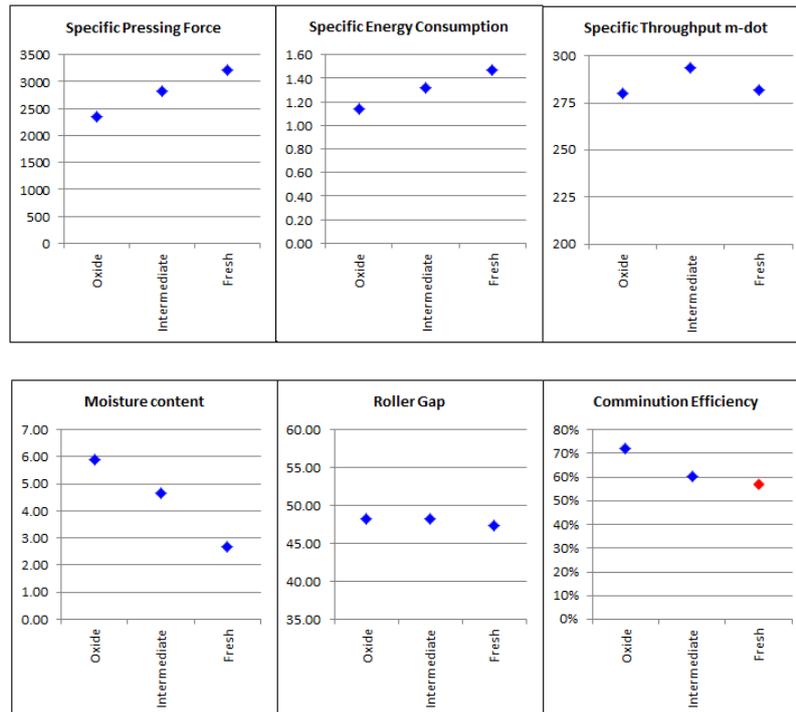
Figure 13 - HPGR process KPI's

Please note comminution efficiency for fresh feed (red data point) is based on cumulative % passing 3 mm. Oxide and intermediate ore types (blue data points) refer to 4mm screen aperture

The summary statistics confirmed proper operation of the HPGR and expected machine response to changing feed conditions. As the feed material increased its competency the following changes were observed:

- In order to maintain adequate levels of comminution specific pressing force was increased from 2,300 kN/m² to 3,200kN/m²
- The change in specific pressing force resulted in an increase in specific energy consumption of ~33%
- Process specific throughput remained steady for all three types of ore.
- Change of ore type from oxide to fresh resulted in a substantial reduction of HPGR feed stream moisture.
- Operating roller gap is steady for all three ore types indicating good process control
- Deterioration of comminution efficiency was expected when process progressed to harder ore. However even for intermediate and fresh ore types the comminution efficiency was excellent and this allowed TGM to reduce HPGR screens aperture thus reduce Ball Mill feed top size.

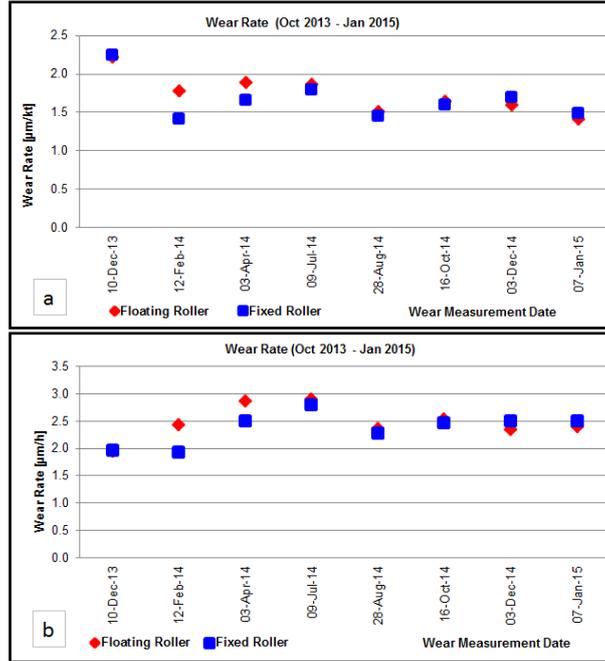
Figure 14 - Stud lining wear rate for period from commissioning in October 2013 - January 2015
 (a)Wear rate in microns per '000t of total HPGR throughput (b)Wear rate in microns per on load hour

As expected the wear rate ($\mu\text{m}/\text{kt}$) of operation was much higher compared with the rest of the period. Once the process stabilized the wear rate settled at ~1.6 to 1.7 $\mu\text{m}/\text{kt}$.

The wear rate measured in $\mu\text{m}/\text{h}$ beginning of September 2014 the wear lining reached the warranted 6,000 operation hours. The condition of the lining continued to be very good and in February 2015 the original lining was still in service after more than 8,000 on-load hours.

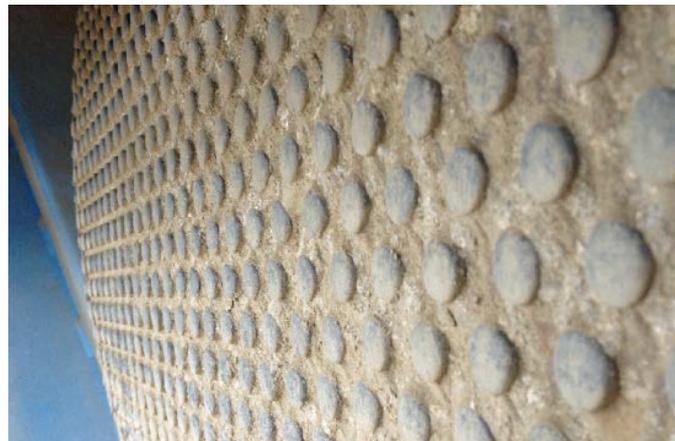
Figure 15 - Wear lining condition ~1,000 hrs in service (courtesy of AngloGold Ashanti)

Figure 15 shows wear lining with autogenous protection layer (APL) present. Please note very uniform and compact APL and even wear of studs. Figure 16 presents lining after autogenous protection layer was removed, stud protrusion is uniform – 5 to 6 mm.

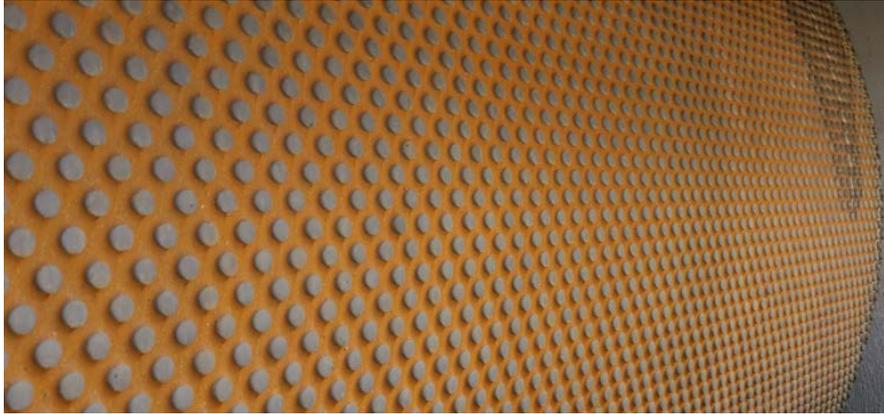
Figure 16 - Wear lining condition ~8,500 hrs in service (courtesy of AngloGold Ashanti)

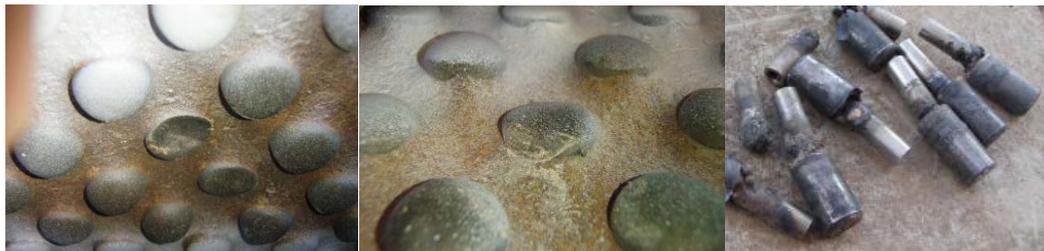
Breakage of center studs was also very minimal with an odd stud chipping or breaking occasionally. During the 11,000 (May 2015) hrs of operation less than 30 studs broke or chipped (please note the entire lining is composed of some 38,000 carbides). Some of the studs were replaced during planned plant shut downs.

Figure 17 - Examples of broken, chipped center studs and studs removed from wear lining during maintenance (courtesy of Anglo Gold Ashanti).

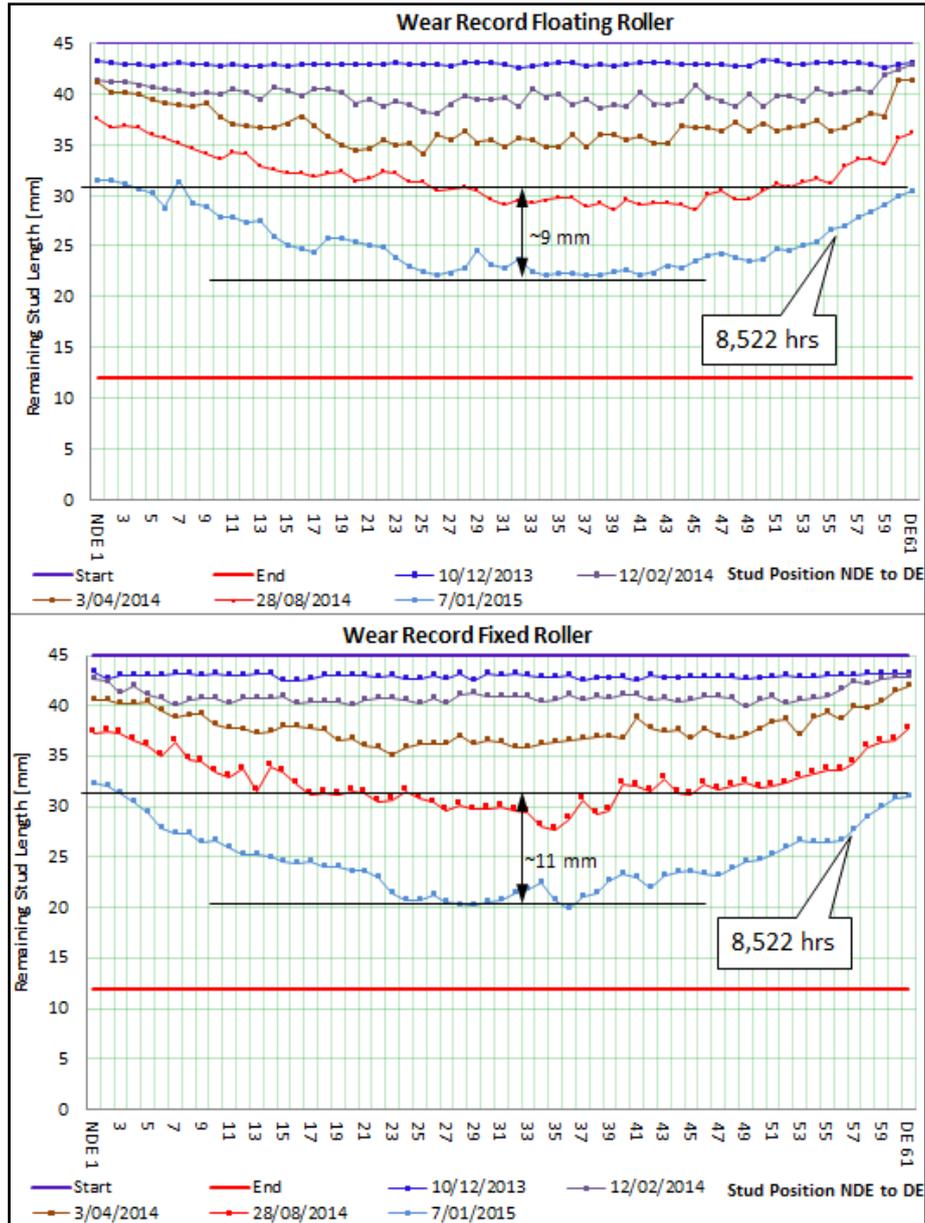
As expected the wear lining developed a so called “bath-tub” profile. Towards the end of wear lining life the ‘bath-tub’ profile made process control more challenging but not impossible.

Figure. 18 - Wear profile progression from start to 8,500 on load hours
